# Cleansing and Care of a Deep and Narrow Wound with Easily Accessible Medical Equipment

## Case Report

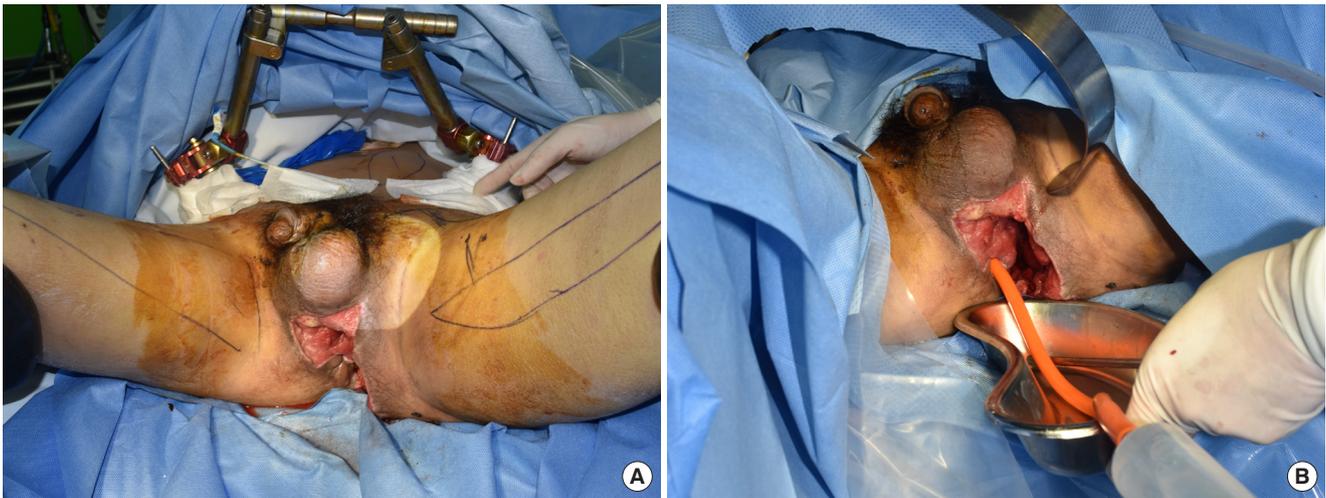
**Fig. 1.** Perineal wound 3 weeks after trauma. (A) The wound has an opening on the perineum of the patient. The wound involved the anus and a loop colostomy was performed so the wound was separated from the fecal contamination. (B) A rectal tube was inserted from the opening of the perineum. The irrigation was performed with the pressure directed by the physician and the leakage from the wound was collected in the tray placed underneath.

The wound was in the shape of a deep tunnel with a dead end where pus collected. The pus would not drain naturally because the patient had fractured his pelvic bone and was unable to change his position. To drain the wound, a rectal tube was inserted all the way through the tunnel and saline irrigation was performed twice every day (Fig. 1). Normally, a rectal tube has only one opening at the end of the tube, so several holes were made to help irrigate the tunnel (Fig. 2). The tube was changed every 3 days, and was kept in position after the irrigation so as to facilitate even minimal natural drainage.

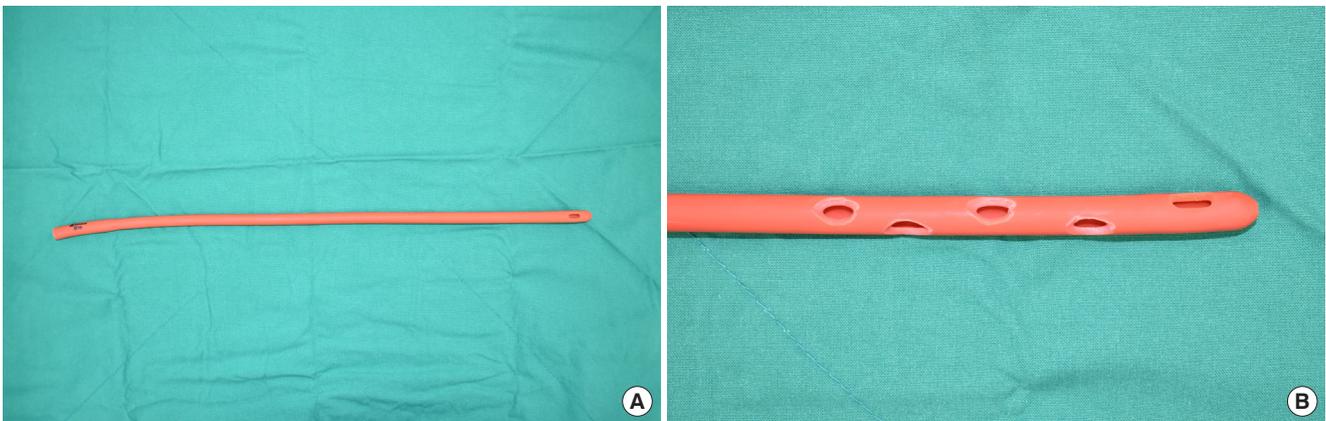
**Fig. 2.** Gross photography of the irrigation (rectal) tube. (A) The 32-Fr rectal tube shown is used for irrigation. (B) Distal part of the same rectal tube with several holes made.

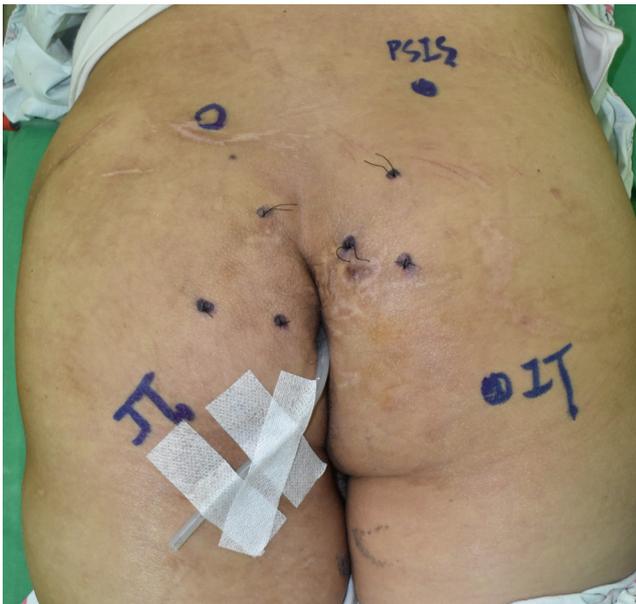
**Fig. 3.** Gross photograph of inserted Foley catheter. The tube was not removed after dressing, allowing the tube to facilitate natural drainage from the wound.

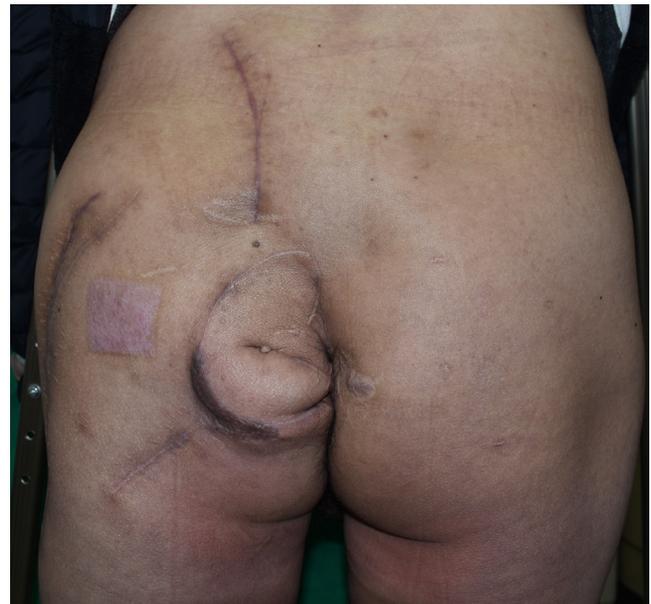
**Fig. 5.** Gross photograph 8 months after flap coverage. Complete wound healing without any complications.

management. Three weeks after the flap coverage, the wound was almost fully healed with a minimal skin defect and without any complications such as trapped pus or fluid collection within. At 8 months after surgery, the wound exhibited no complications or recurring infections (Fig. 5).

The case presented a wound difficult to manage up to the point that soft tissue coverage was restored. Though it was precise and methodical irrigation that delivered successful outcomes, other wound treatments had also been attempted. Negative pressure wound therapy (NPWT) was tried several times, but it failed to drain the deeper part of the wound as effectively as the gauze soaking. Curettage and dressing with betadine-soaked gauze also turned out to be less than successful in draining and cleansing the base of the wound. The physicians also considered making a drainage pathway from the deepest part of the wound all the way to the patient's backside, but they did not try it because this procedure is known to have high morbidity. The tube irrigation method was the procedure that was finally chosen. Though the wound shrank in size only very slowly, there were no further infections or aggravations. At 8 months since the flap coverage, there had been no complications.

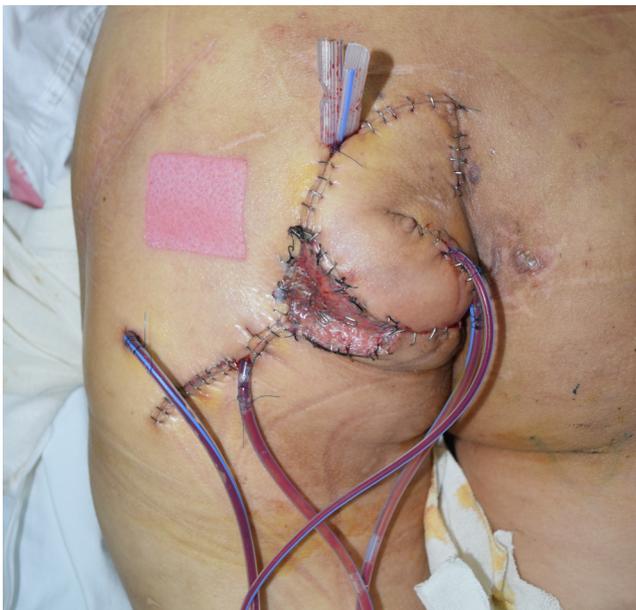
**Fig. 4.** Gross photograph after flap coverage. A perforator perineal artery flap was used to cover the soft-tissue defect after the pelvic bone was stabilized.

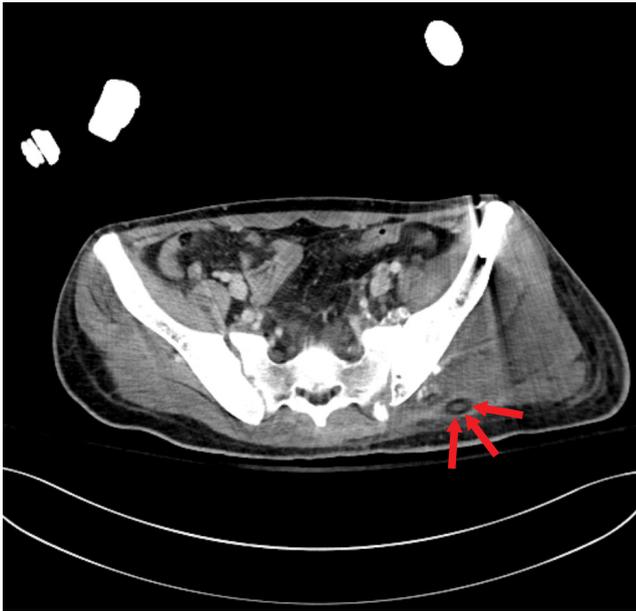
**Fig. 6.** CT scan showing the inserted irrigation tube. An irrigation tube (a rectal tube in this CT scan) is shown in this axial cut image (red arrows). Fluid collection can be seen just lateral to the rectal tube. CT, computed tomography.

The case described in this article, where the wound was irrigated using tubes, provided a number of new attempts. First, the course of the irrigation tube was tracked in imaging studies such as computed tomography (Fig. 6), ascertaining the irrigation was cleansing the necessary places throughout the narrow wound. Second, the color of the saline first irrigated provided insight on the nature of the pus or discharge from the deepest point of the wound. Furthermore, instead of using closed drain lines that only fit normal syringes with small openings, in this case rectal tubes or Foley catheters with wider openings that fit on enema syringes were used, making massive irrigation possible. The syringes also made it easy to control the irrigation pressure. Moreover, the universal tubes used in this case enabled use of other medical equipment, such as hanging a urine bag filled with saline on an intravenous stand and connecting it to the tube for continuous irrigation. Simply adjusting the height of the intravenous stand would change the rate of irrigation.
